INFRARED THERMOGRAPHY

For Metal Roof Inspections

By Ronald D. Lucier, regional thermography course manager, FLIR Systems Infrared Training Center, and Leonard Phillips, senior writer for thermographic applications, FLIR Systems

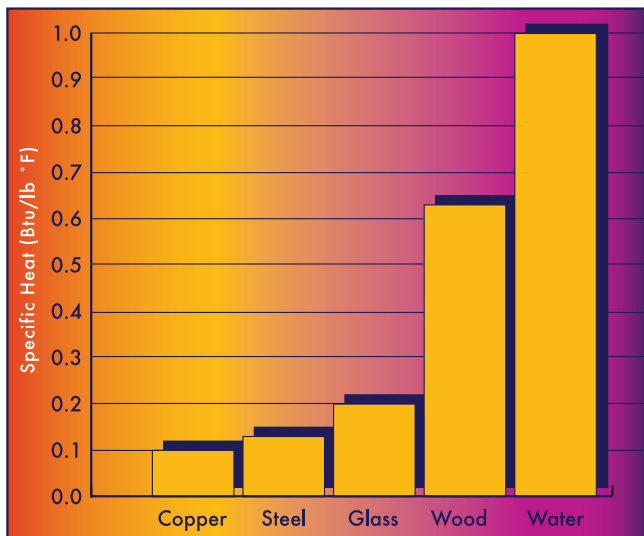
Table 1. Specific heat of various substances. The greater a material's specific heat, the more energy required to heat or cool the material. Water has a much higher specific heat than wood and subsequently cools down or heats up much more slowly than wood under similar conditions. This difference in temperature can be imaged and measured using an IR camera.

When conducted at the right time of day, IR inspections can determine which materials are wet or in contact with wet materials and which are dry. This is possible because water has a high specific heat, which means that it stores heat well and cools down more slowly than common building materials (see Table 1).

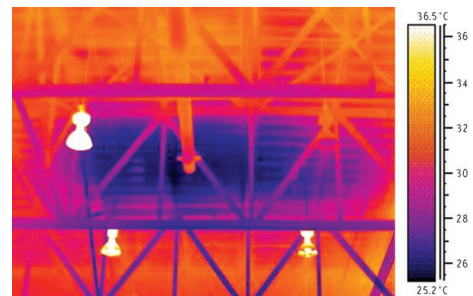
Figure 1. Thermogram during the morning from under a standing-seam metal roof, looking up at the underside of the deck. The sun has warmed up the dry areas of the roof, which appear red and orange. A wet section, not yet as warm as the dry areas, appears purple.

Here's how it works. Just as wet materials cool down more slowly than dry materials, they also warm up more slowly. So after sunrise, the dry portions of the roof heat up faster than the wet areas. Seen from underneath a metal or wood deck, wet areas will appear colder in the infrared (see Figures 1 and 2).

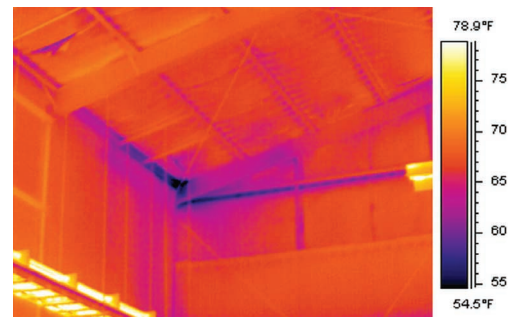
Figure 2. Thermogram of a leaky corner of a large electrical utility building, looking up at the underside of its standing-seam metal roof. The infrared emissivity of the wet materials is 0.98, compared with the emissivity of the metal roof itself, which is only about 0.01. Water has soaked the building walls as well as the underlying roof substrate.

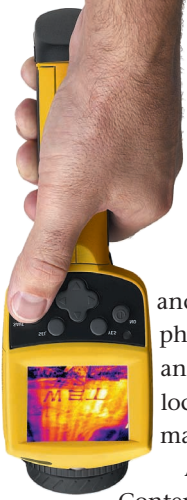
Figure 3. The ThermaCAM RoofCAM from FLIR Systems is a small, lightweight infrared camera designed specifically for roofing and building envelope professionals. The size of a flashlight, it weighs only 1 1/2 pounds with batteries and can store up to 100 images in standard JPEG format and download them to a PC for report generation. A bright red-dot laser designator makes it easy to outline wet areas.

that shows wet areas (see Figures 3 and 4). Conduct a wide-area scan first to confirm that the inspection window is open and good-quality images can be obtained. Then systematically scan the roof and the underside of the deck where possible. Leaks can occur near seams, penetrations, drains, and punctures. Photo document everything in infrared as well as in visible-light photography.

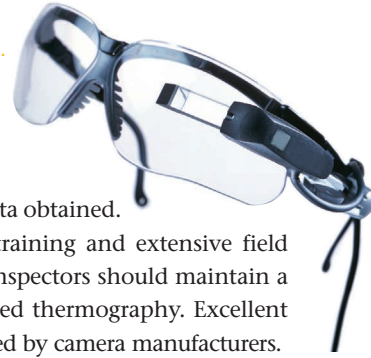
Figure 4. This heads-up display from FLIR Systems projects the infrared image onto a pair of safety glasses. This enhances worker safety by enabling the thermographer to see the image without having to look into an eyepiece or LCD screen.
